OPEN ACCESS
Jurnal Ilmiah Ilmu Terapan Universitas Jambi
Vol. 10 No. 2. April 2026, pp. 1144-1155 DOI. 10.22437/jiituj.v10i2.52827
Review Article

SYSTEMIC FAILURES IN LITHIUM-ION BATTERY FIRE FATALITIES: A CASE STUDY OF THE TERRA DRONE BUILDING

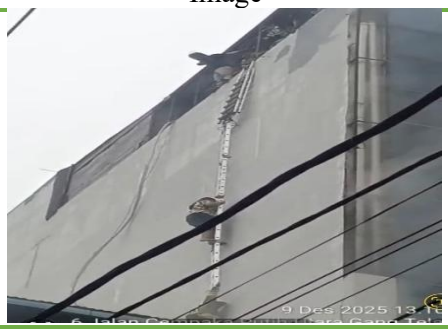
No	Image	Note
5.

Evacuation through the rooftop using stairs.
